River bank restoration on the upper Danube between Vohburg and Neustadt/Donau for habitat enhancement and improvement of ecological status

Status quo

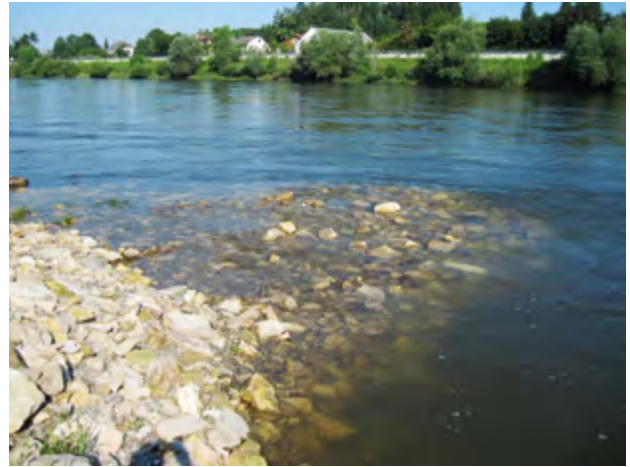
Figure 2. Steer groins using rocks from embankments, covered during medium discharge

Starting in 2010, riprap was removed and the stones were used for building 8 to 10 m long triangular steer groins along the bank (*figure 2*). The groins are slightly inclined with the current which created alternating overflowing and non-overflowing sections. They guide the water flow to the unprotected banks and initiate side erosion, bank and flow diversity (zones for rheophilic species with high flow and zones for more limnophilic species with low current) and create varying depths and little bays with various substrates. Dead wood (*figure 3*), bundles of willow branches and trunks of trees were used sometimes to emphasize the effects and created new habitats.

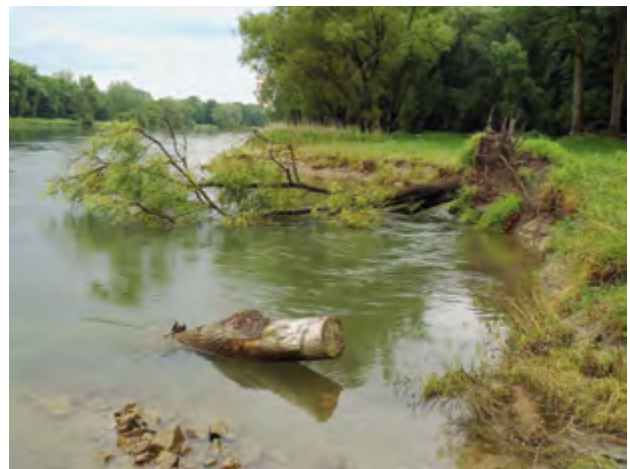
Figure 3. Introduced dead wood from the riparian zone in the inter-groin field

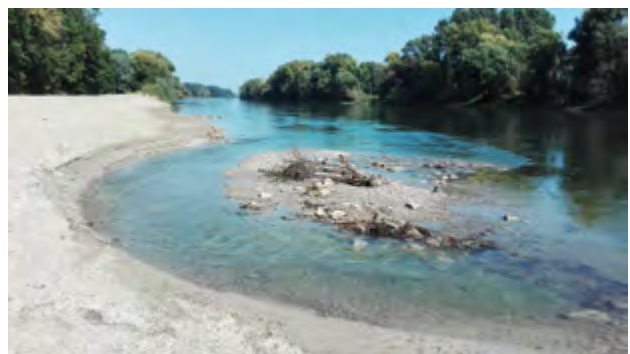
Figure 4. "Island groins" with shallow gravel banks and side streams

Similar to the groins described above, oval groins where the current has to circle around, were built within 5 m from the shore, 10 m long and slightly inclined to the current. They act like small islands producing high flow and substrate diversity with side streams (*figure 4*). While the rocks from the embankment were used for building the groins, the silt depositions had to be removed by chain dredger and trucks (*figure 5*). They were used for dyke construction nearby.

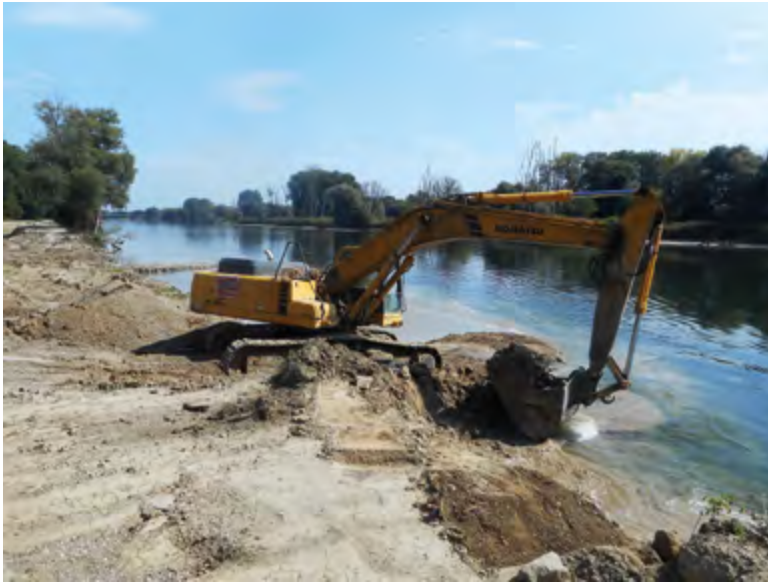
Figure 5. Removal of embankment and silt deposition by chain dredger

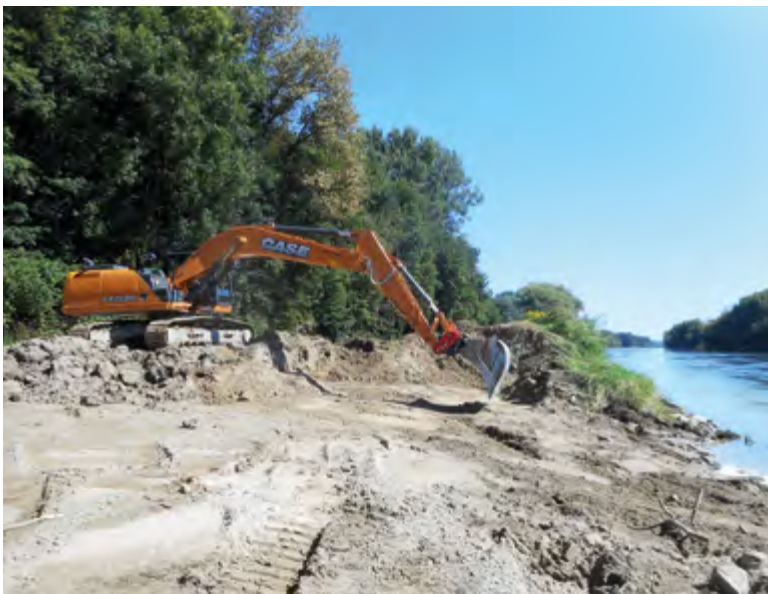
Figure 6. Shallow water zones with gravel banks

At the start of restoration silt depositions were removed to the original level and the extracted material was used for dyke restoration. After clearing the foreshore, the embankment rocks were shifted towards the Danube. In this way aquatic and semi-aquatic zones were connected and accessibility for humans was made possible (figure 6).
