Major obstacles for Danube sturgeon spawning migration: The Iron Gate dams and the navigation project in the Lower Danube

Jürg Bloesch: IAD, Zürich, Switzerland,
e-mail: Juerg.Bloesch@emeriti.eawag.ch

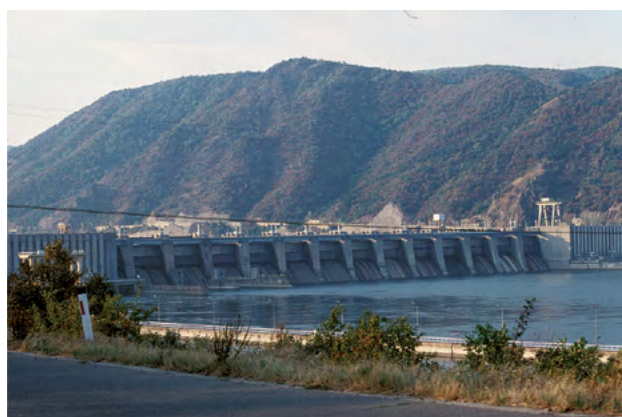
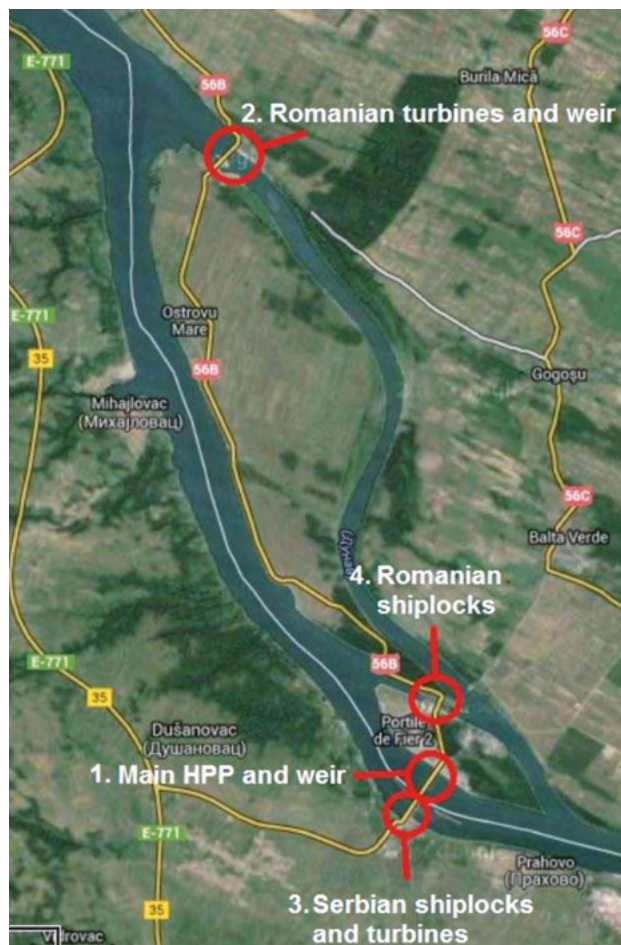
Figure 1. The Iron Gate Hydropower dams. While the Iron Gate I dam (left) is a single obstacle, the situation at Iron Gate II (right) is extremely complex with two hydropower stations and two ship locks (Sources: Photo Jürg Bloesch; de Bruijne et al. 2014)

When the Iron Gate hydropower dams were constructed in 1972 and 1984 (rkm 943 and 862, *Figure 1*), the disruption of fish migration was not an issue. After great peaks of arriving sturgeons, stopped by the first dam and harvested by fishermen in the 1970s, there was a significant decline (Reinartz & Bloesch 2006). In the late 1990s, when a general decrease of fish populations across Europe became evident, the problem of disrupted fish migration by dams received high recognition in aquatic science and river

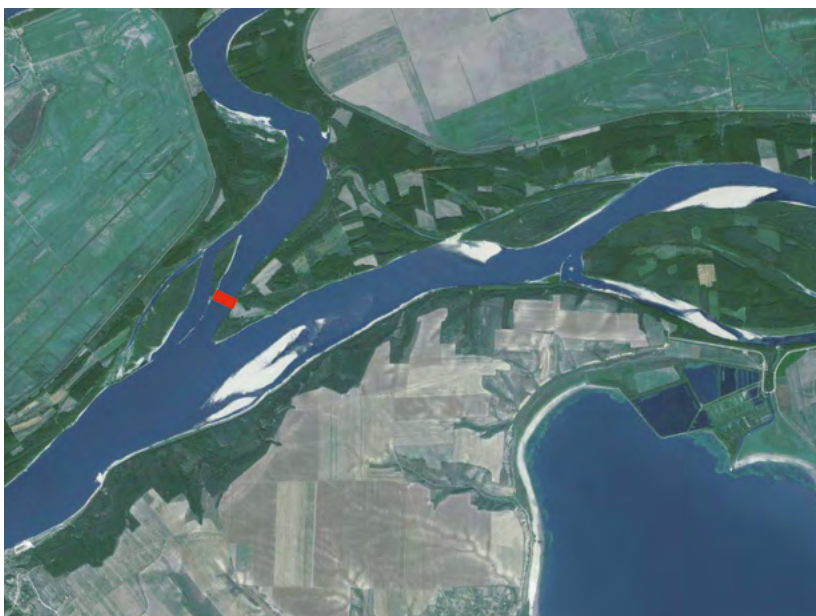
Figure 2. The bifurcation Bala Branch – Old Danube near Braila. The partly constructed submerged sill in the Bala Branch (red line) and the guiding wall along the left bank have increased the local flow velocity and, consequently, the erosion of the river bottom. Only few sturgeons could occasionally pass the sill and spawning migration is disrupted. Presently, alternatives are being evaluated (Source: AFDJ, Galati, WS 7 October 2015)

are now slowly promoted, the construction of a submerged sill in the Bala Branch, in contrast, will strongly hamper if not disrupt sturgeon migration (Figure 2).

bated by the monitoring team and the navigation authority (AFDJ). While monitoring showed that out of 315 tagged individuals, only 10 could pass the unfinished sill (Deak & Matei 2015), this is by far an insufficient number to maintain a sturgeon population. Such coincidental passages have also been documented at the Iron Gates ship locks when single specimens of beluga were recorded in the Middle Danube. Further, it took a recorded beluga male sturgeon about 14 hours to pass the sill, indicating stronger currents at the sill crest, a measurement that is still missing. We know that such delays accumulated by consecutive fish passes may result in strong bias of spawning, since the fish lose a lot of their energy and arrive too late at the spawning sites. As a result of this controversial situation, the construction of the sill has been stopped, and alternatives including decommission of misvalued built constructions are now discussed.
